WL-TR-97-4054

**PROCEEDINGS OF THE 1996 USAF
AIRCRAFT STRUCTURAL INTEGRITY
PROGRAM CONFERENCE**

Dr. Hal Burnside*

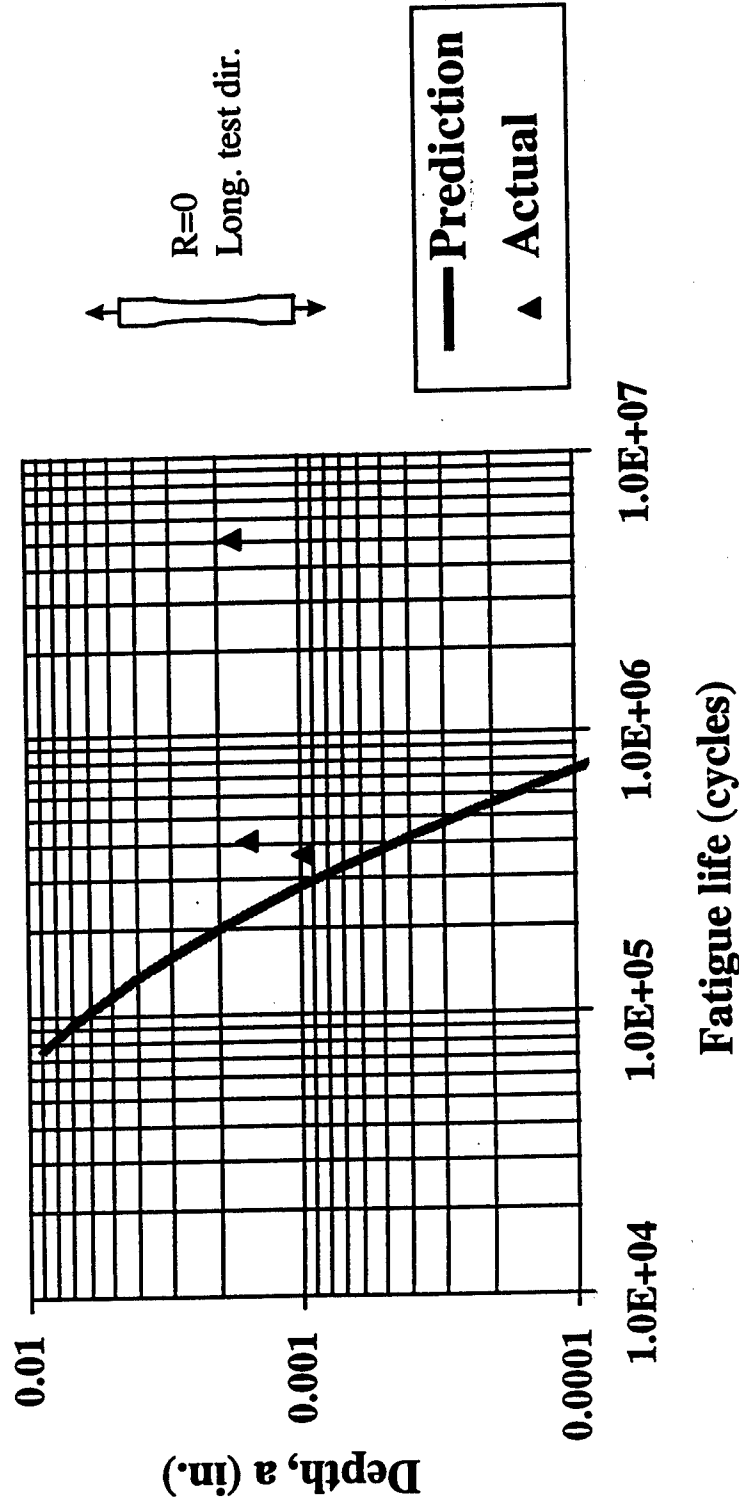
20 ksi: microfeature depth vs. cyclic life

7150-T77511 extrusion with surface IGC

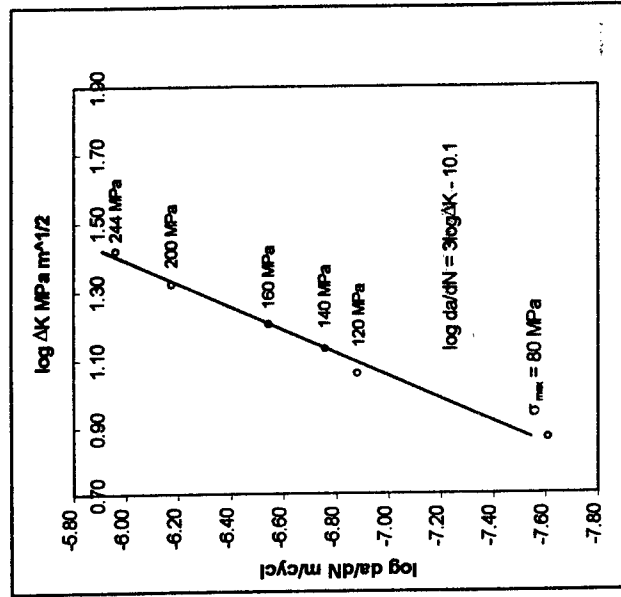
AMRL Crack Growth Prediction Studies

- Crack Growth Independent of Crack Length

$$a = A_R \int_0^N (\Delta K_\infty)^{n_R} dN$$

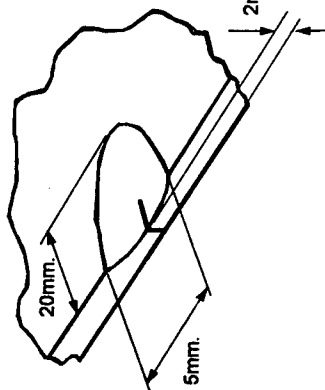
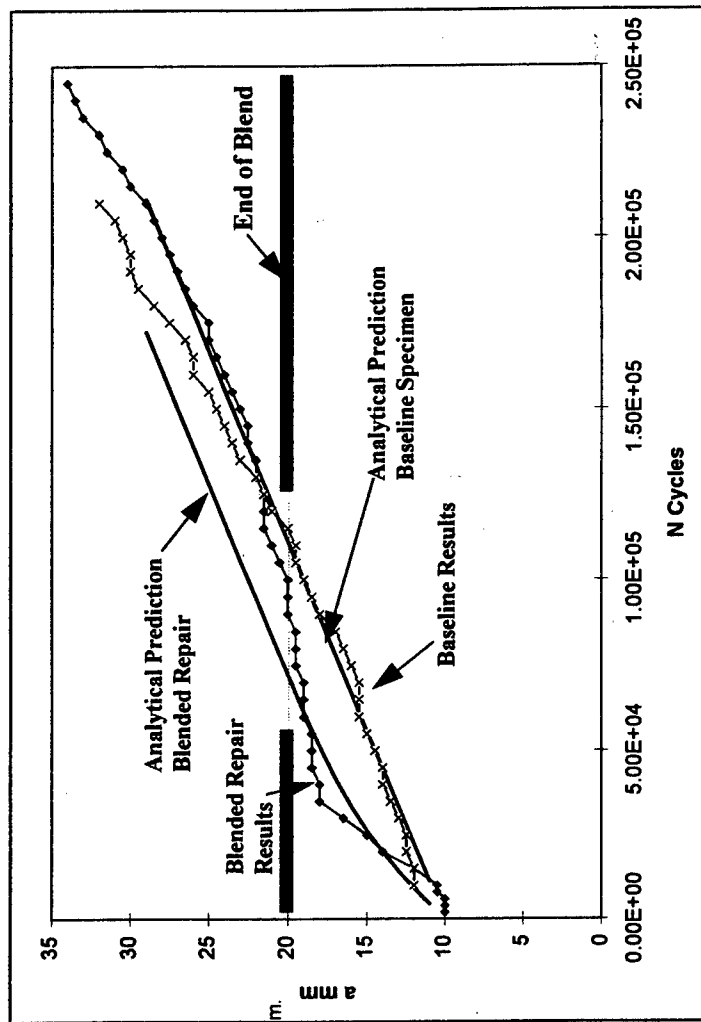
Blend-out Crack Growth Results

- Simplified Predictive Methods

- ◇ Based on Stress Levels in Metal With Blend
- ◇ Correlate with Trend

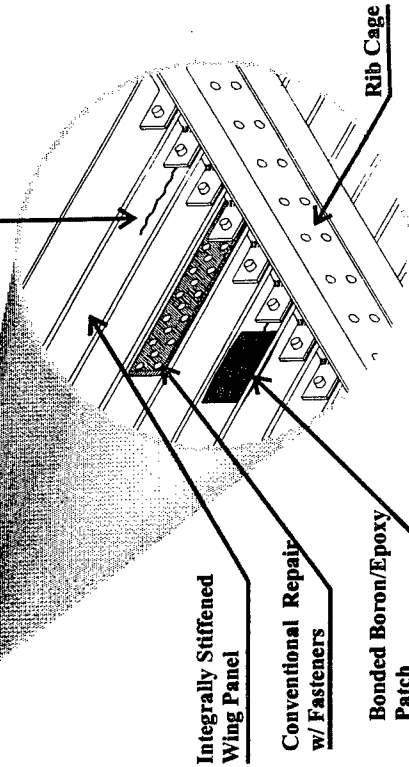
Case Study #1 : C-130 Outer Wing Planks

- Stress Corrosion Cracking in Stiffeners
- Induced By Fasteners

- Boron/Epoxy Bonded Repair Applied Inside the Wet Wing
- Over 1000 Repairs Applied With No Crack Growth in 20 Years
- Estimated Savings \$67 Million

Stress Corrosion Cracking

Completed Repair

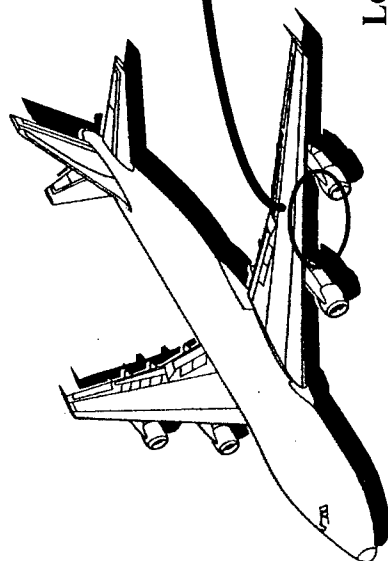
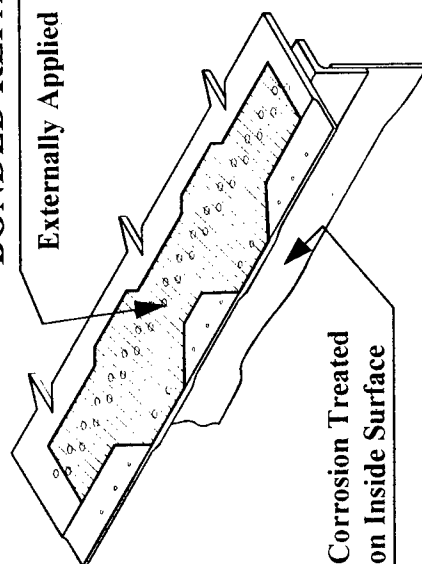
Case Study #4 : B-747 Lower Wing Skin

Front Spar

Corrosion

BONDED REPAIR

Externally Applied

Corrosion Treated on Inside Surface

View Looking Onto Lower Wing Skin

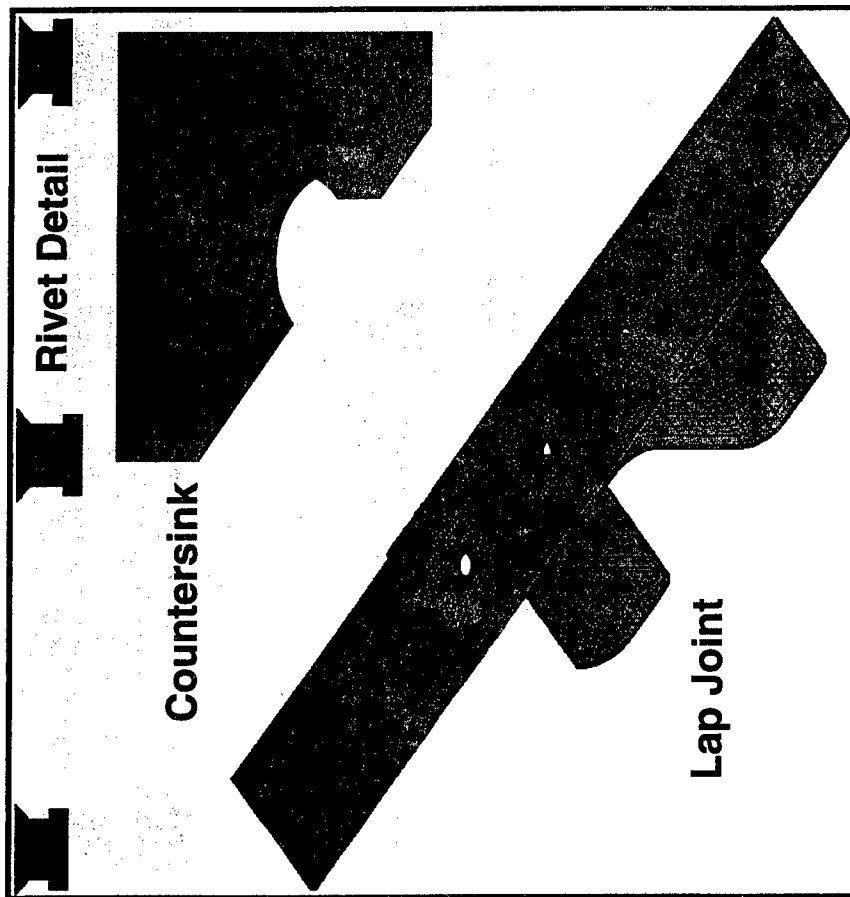
Finite Element Model

Stress Analysis

- 3D finite element analysis.
- Rivet/skin interaction simulated using nonlinear gap elements.
- Three separate loading conditions:
 - 1) hoop stress
 - 2) rivet pre-stress
 - 3) corrosion pillowing

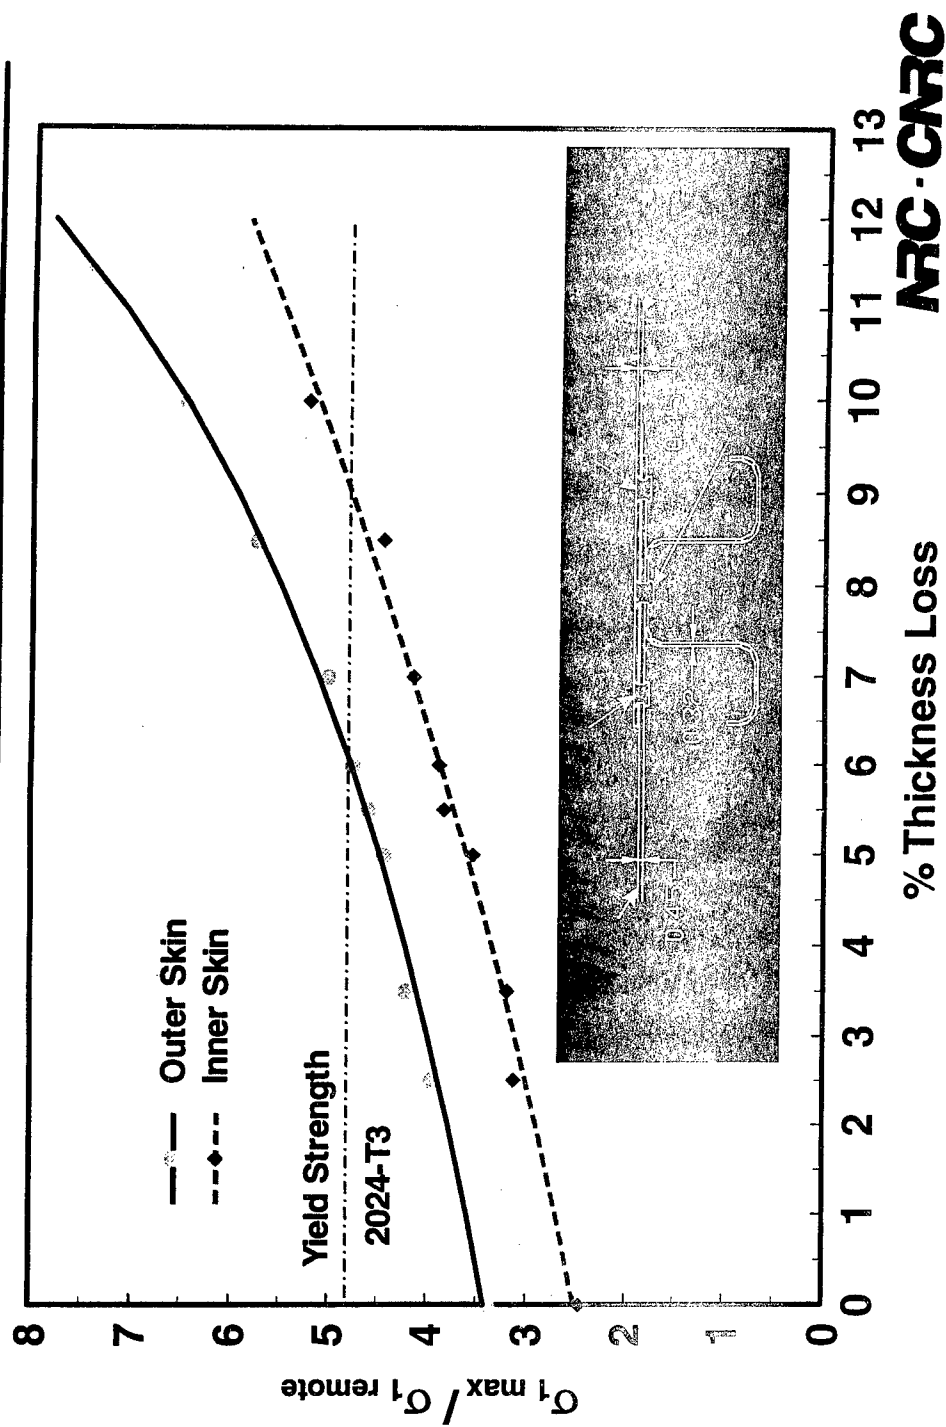
Effect of Pillowing

Two layer lap joint - upper rivet row

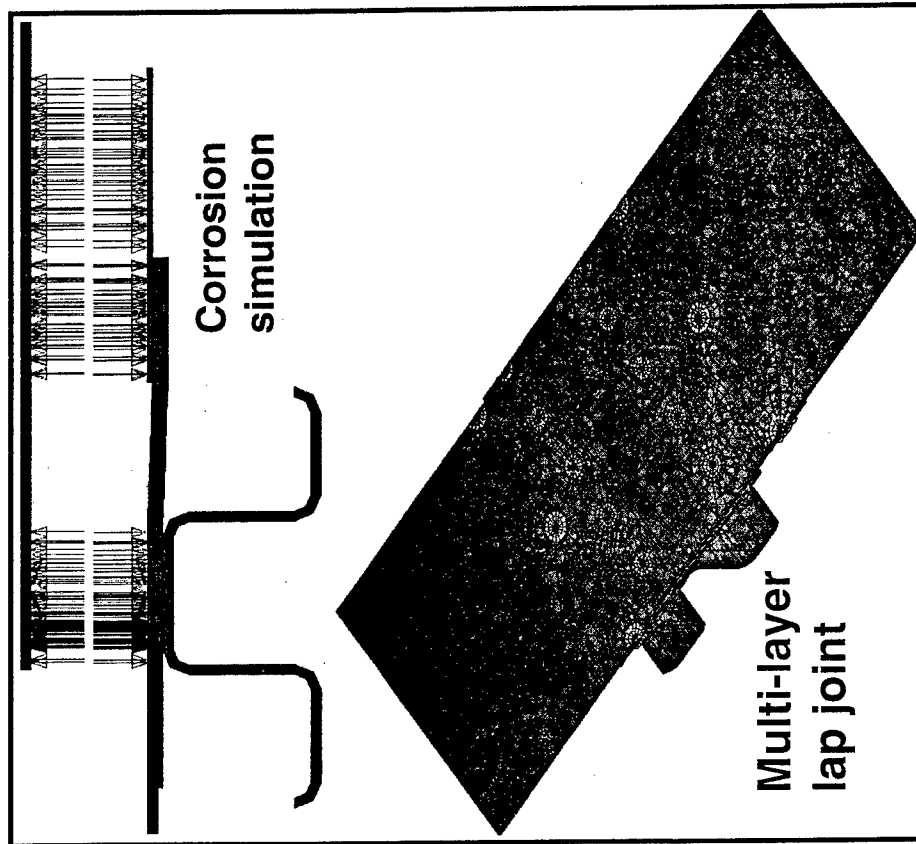
Finite Element Model

Stress Analysis - Multi-layer lap joint

- 3D finite element analysis.
- Rivet/skin interaction simulated using nonlinear gap elements.
- Three separate loading conditions:
 - 1) hoop stress
 - 2) rivet pre-stress
 - 3) corrosion pillowing

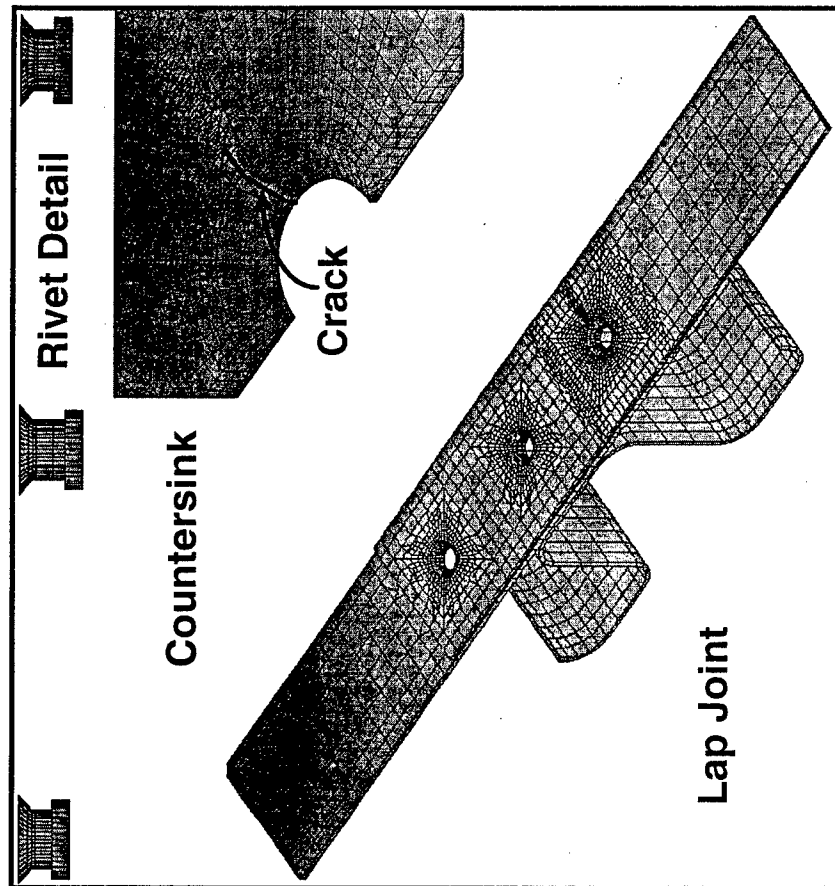
Finite Element Model

Fracture Mechanics Analysis

- Stress analysis model except for:
 - Second order elements in area of critical rivet row.
 - Mid-side nodes at crack tip moved to quarter point to simulate stress singularity.

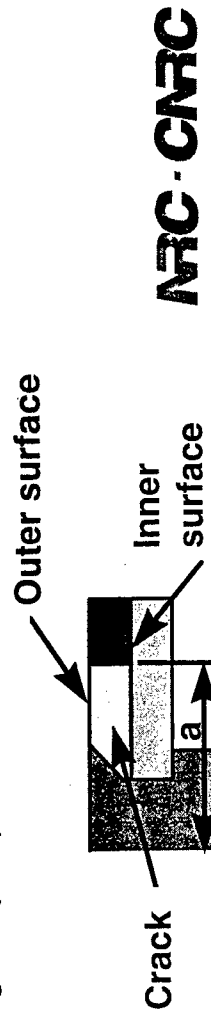
Fracture Mechanics Analysis

Stress intensity for crack edge along outer surface

- Stress intensity for crack edge along outer surface decreases as corrosion pilling increases.
- Pilling has significant influence on crack in hole vicinity:
 - may arrest crack growth if present before corrosion.

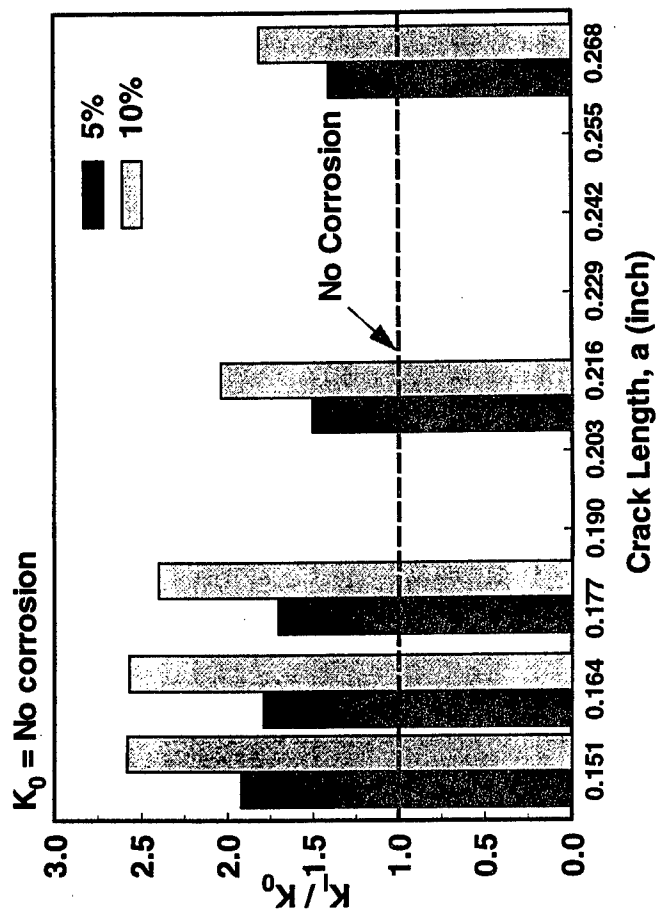
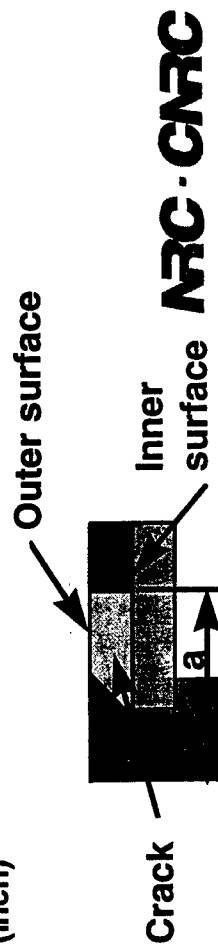
Fracture Mechanics Analysis

Stress intensity for crack edge along inner surface

- Indicates a crack would grow faster along inner faying surface resulting in an elliptical crack with a high aspect ratio.
- Decreasing stress intensity suggests influence of pillowing is reduced (but still significant) away from hole.

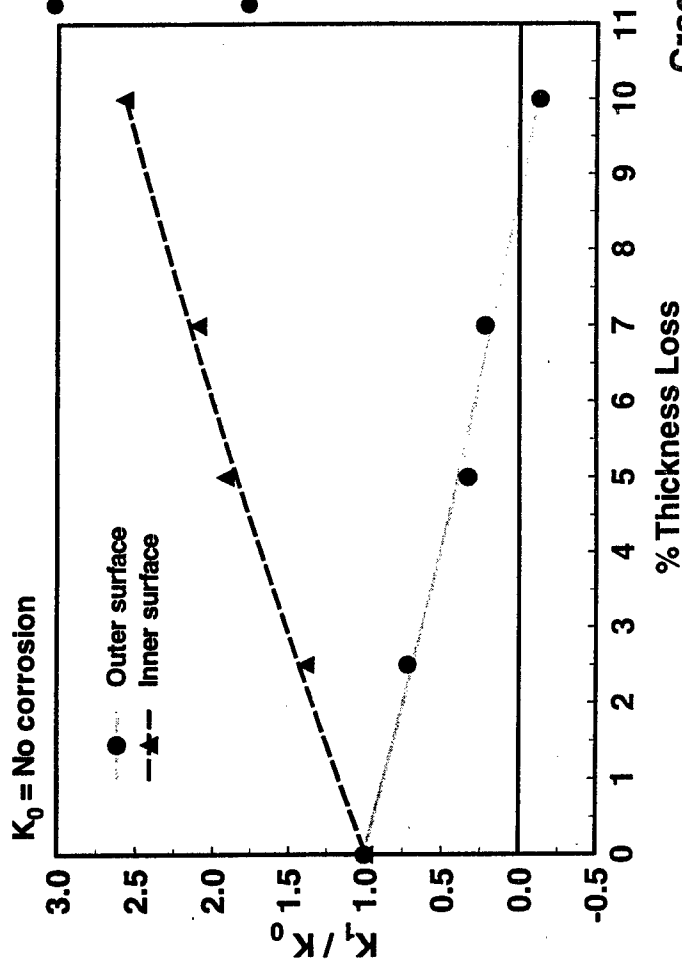
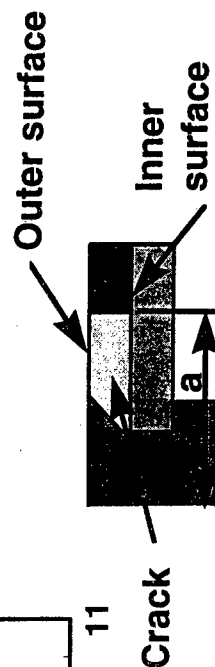
Fracture Mechanics Analysis

Single crack length, $a = 0.15125$ inch

- Suggests semi-elliptical crack with high aspect ratio.
- Crack could be present along inner surface which has not yet penetrated through thickness.

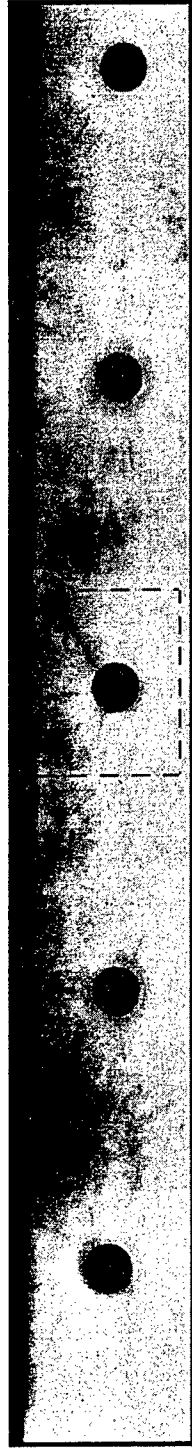
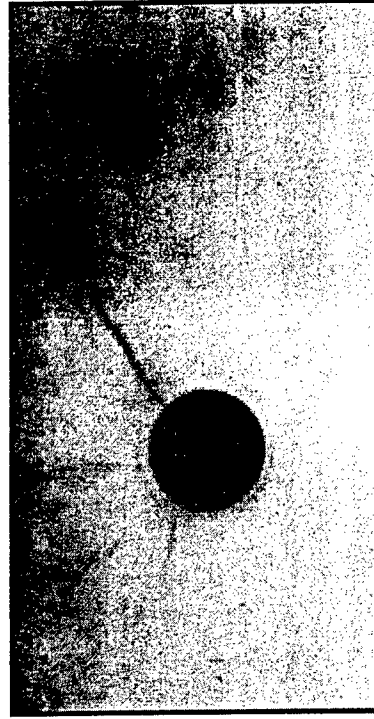
Specimen Teardown

47-18A, Boeing 727-200 N4747, S4R - BS1020

- Upper rivet row inner skin, faying surface (non-critical area).
- Dark areas contain ~10% thickness loss maximum.
- Cracks in the areas adjacent to maximum corrosion pilling.

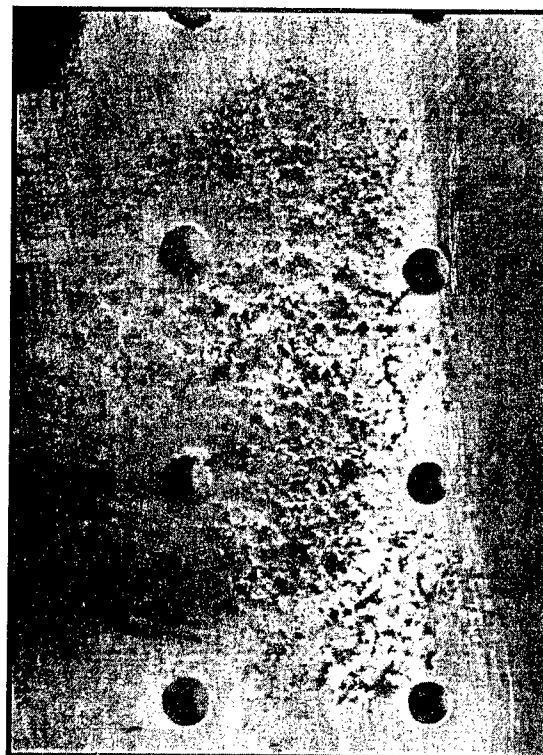
Photograph of
Specimen L1011-1D

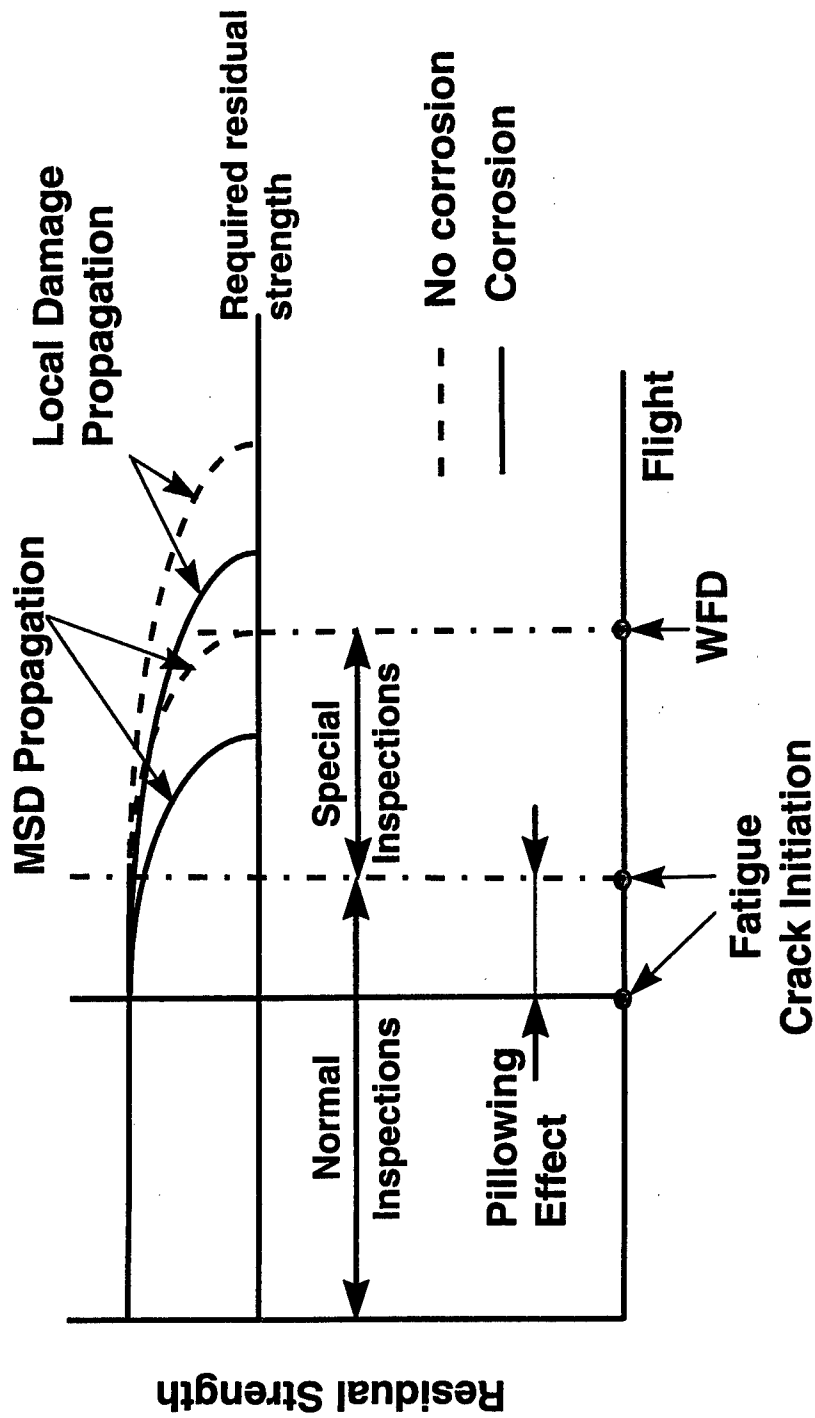
Residual Strength Capability

Possible effect of pillowing on inspection actions

Chart modified from T. Swift, NASA CP 3274

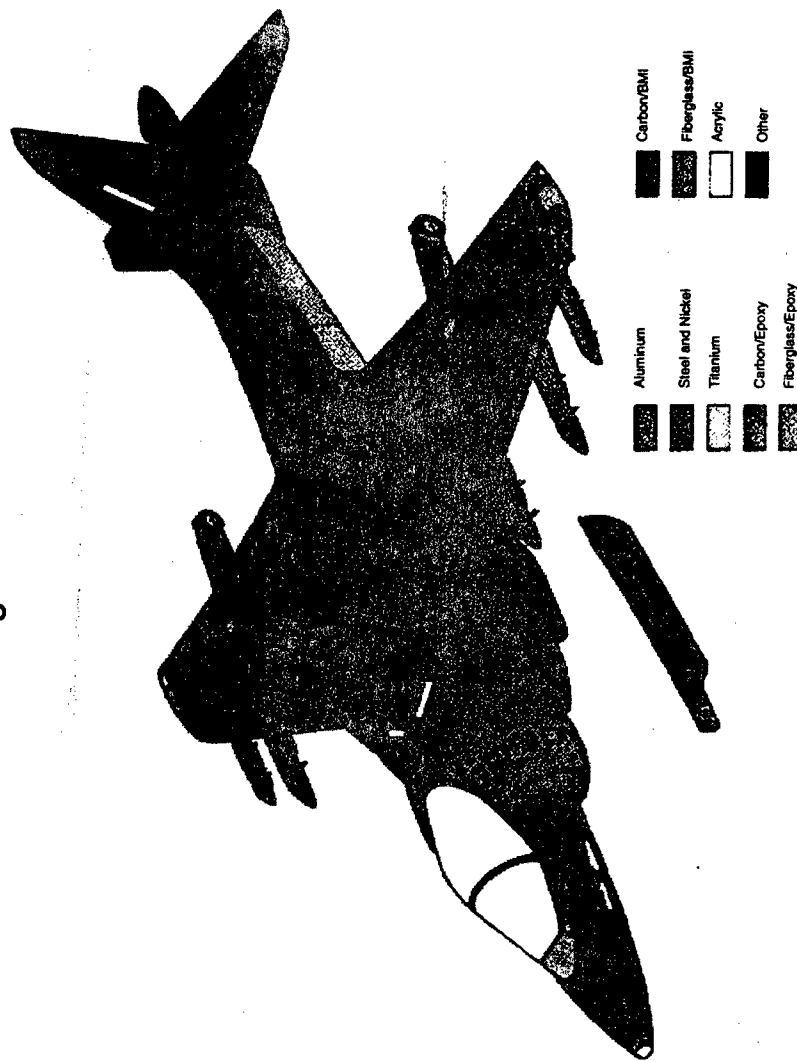
- The Structure of the Harrier Is a Combination of Carbon/Epoxy Composites and Metal.
- The AV-8B Is 26% Composite Materials.

AV-8B Material Usage

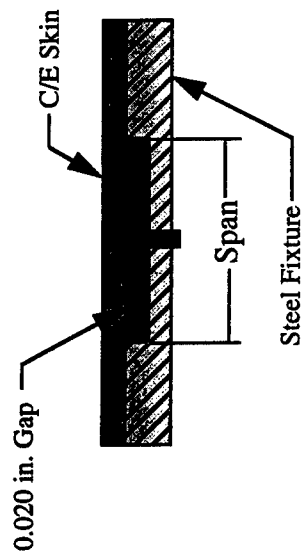
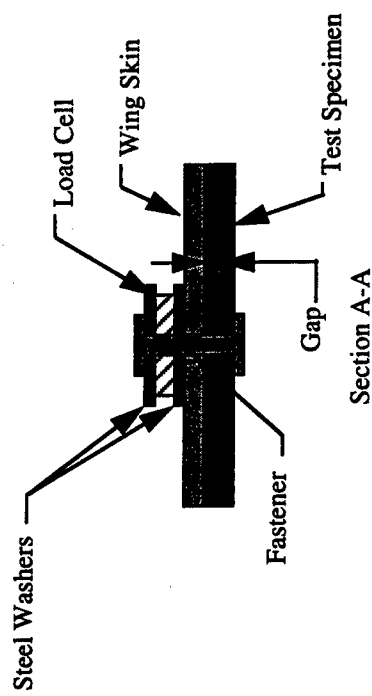
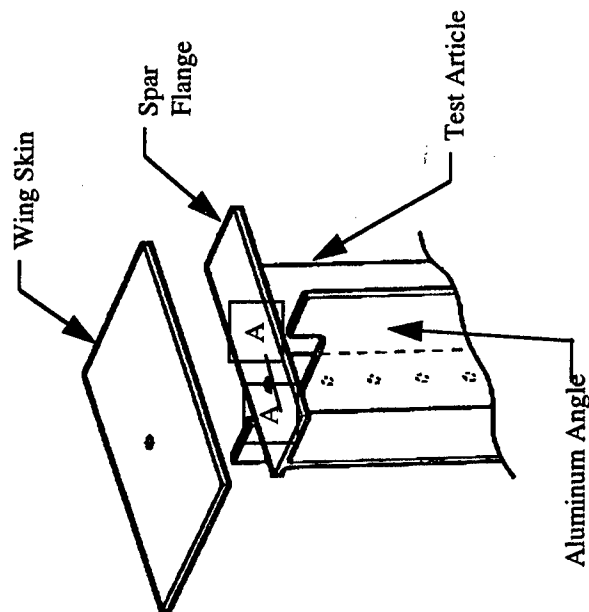
- Delaminations in Test Specimens Were Created by Installing a Fastener Over Unshimmed Gaps Between Specimen Laminates and Simulated Substructure
- The Unshimmed Gaps Varied From 0.020 to 0.080 inches thick over a span of 3 to 6 inches.
- Fastener Torque Versus Clamp-up Force Was Recorded.
- Fastener Torque Applied Were Same As Required in Production.

Delamination Inductions into Test Specimens

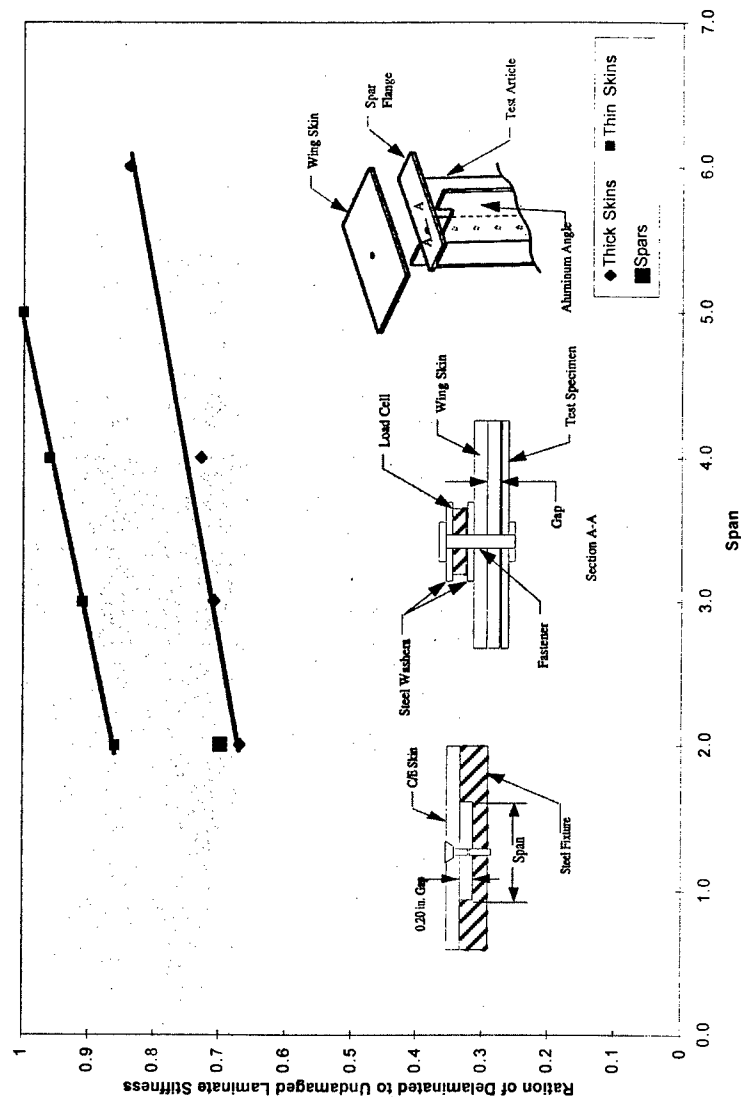
● Delamination Influence on Stiffness

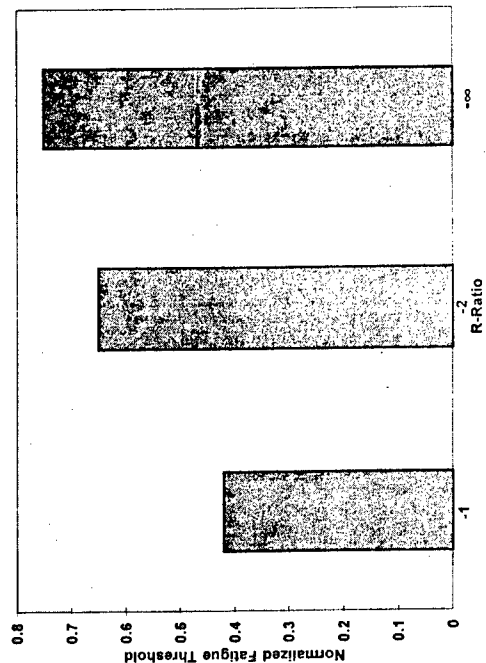
- The Effects of Composite Fatigue
 - Primarily Compression - Compression Dominated Spectrum
 - Test Data Shows That Tension Compression Can Be More Damaging to Delaminated Laminates

- Tension / Compression (T/C) Loading Has Greater Fatigue Effect Than Either Tension / Tension (T/T) or Compression / Compression (C/C) Loadings.
- The Influence of Tension Loads
 - They Do Not Directly Cause Delamination Propagation
 - They Can Cause Laminate Matrix Damage (Subcracking / Crazeing)
 - Laminate Matrix Damage May Lower Compression Load Levels Needed for Delamination Propagation
- Test Program Retained All Tension Fatigue Cycles in Fatigue Spectrum

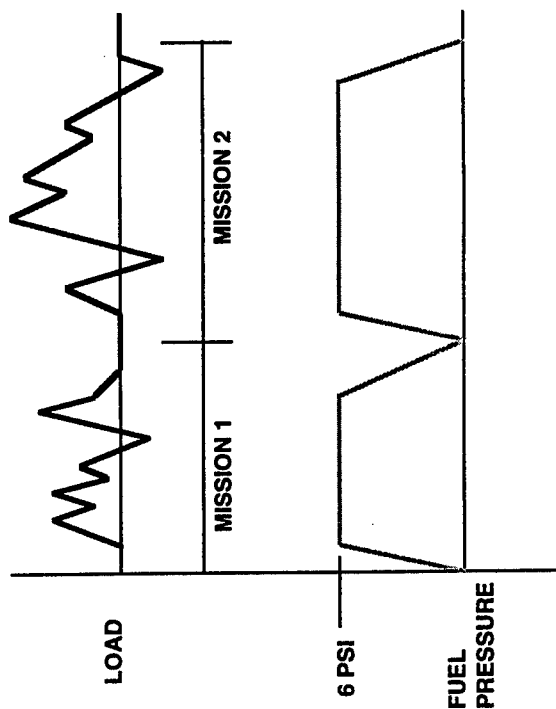
- Out-of-Plane Cyclic Loading:
- Fuel Pressurization Cycles

WING PRESSURE/LOAD RELATIONSHIP

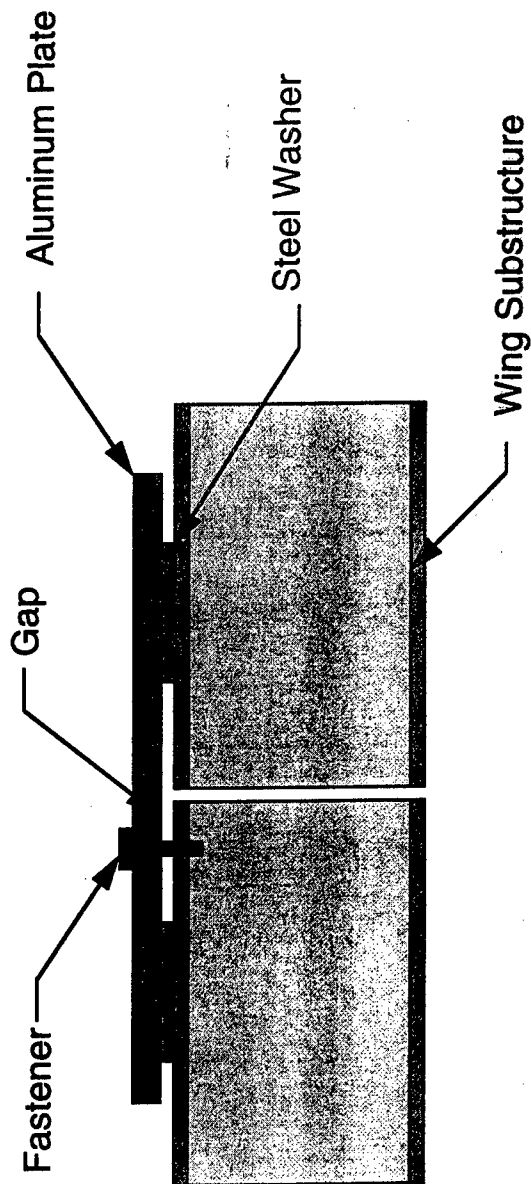
- Delaminations Induced Into UK58 Test Article
 - The Wing was Deskinned
 - Delaminations Induced by Creating Artificial Gaps and installing Fasteners per Production Specification.

Test Article Description

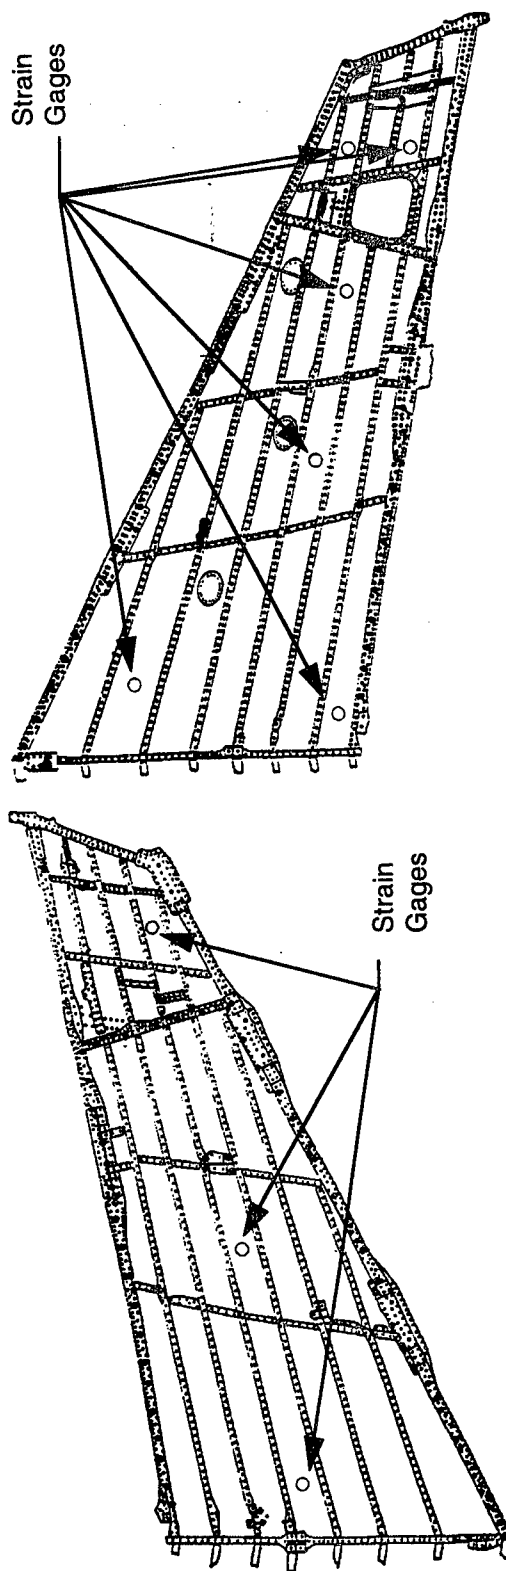
Test Article Description

- Test Article Instrumentation - RH Side Skins
 - Linear Strain Gages and Rosettes Placed in Critical Load Paths.

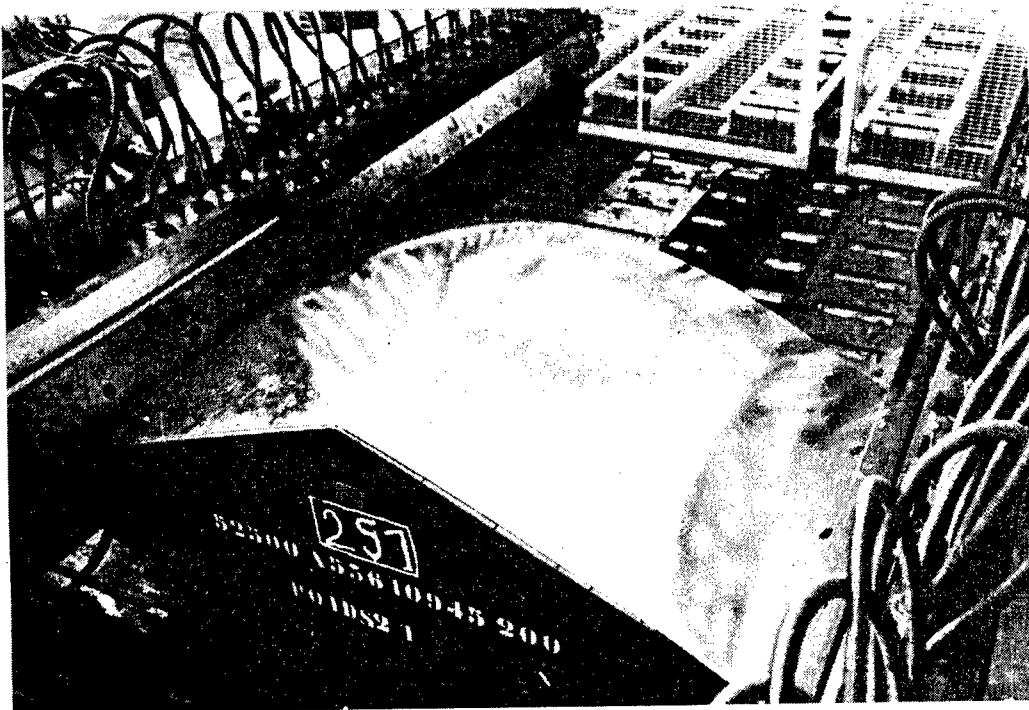
Fig. 5 Stretch formed GLARE® cockpit crown
(Courtesy Aerospatiale)

Extensive research, especially at Delft University and at several OEM's, makes clear that GLARE® can be machined almost equally to aluminum alloys. In certain cases some adjusted tooling is recommended. Workshop experience showed that the learning process is simple and fast. It turns out that GLARE® can be easily drilled, milled, sheared and waterjet cutted. Forming of GLARE® has some limitation, due to the elongation of the fibres. Also springback angles after forming are different compared to aluminum alloys. However, like machining, the learning process is simple and fast. Even very complex parts can be made, which is, among others, demonstrated by Aerospatiale performing a stretch formed GLARE® cockpit crown (Fig. 5).

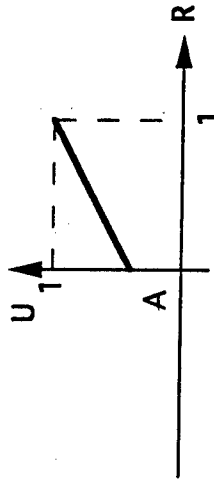
- $\Delta K_{eff}/\Delta K_{nom} = U(R) = A + B R$

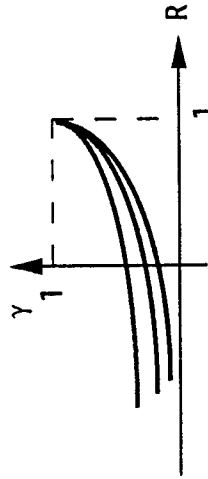
- OVERLOAD EFFECT IS ACTIVE FOR A GIVEN FRACTION (25%) OF THE PRIMARY PLASTIC ZONE SIZE (IRWIN FORMULATION: $r = \frac{1}{\alpha \Pi} \left(\frac{K_{\max}}{\sigma_y} \right)^2$)
- THE SHAPE OF THE OPENING FUNCTION IS CONSIDERED INDEPENDENT FROM THE MATERIAL

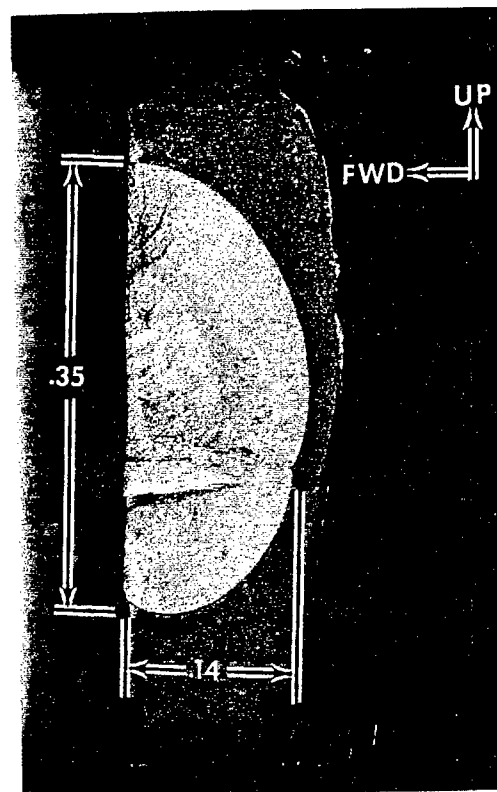
Figure 9a: Multiple Hole Wall Crack Pattern and Extent after Opening

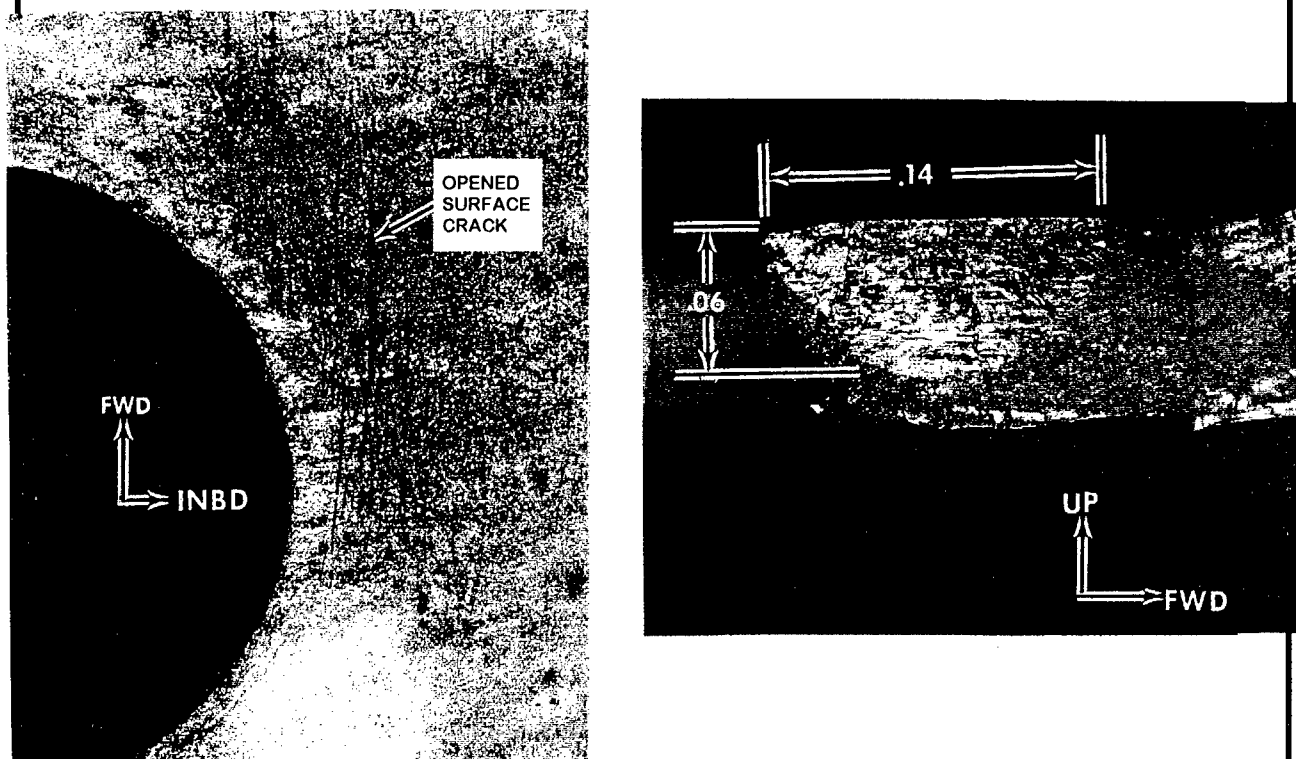
Figure 9b: Typical Surface Crack Pattern and Extent after Opening

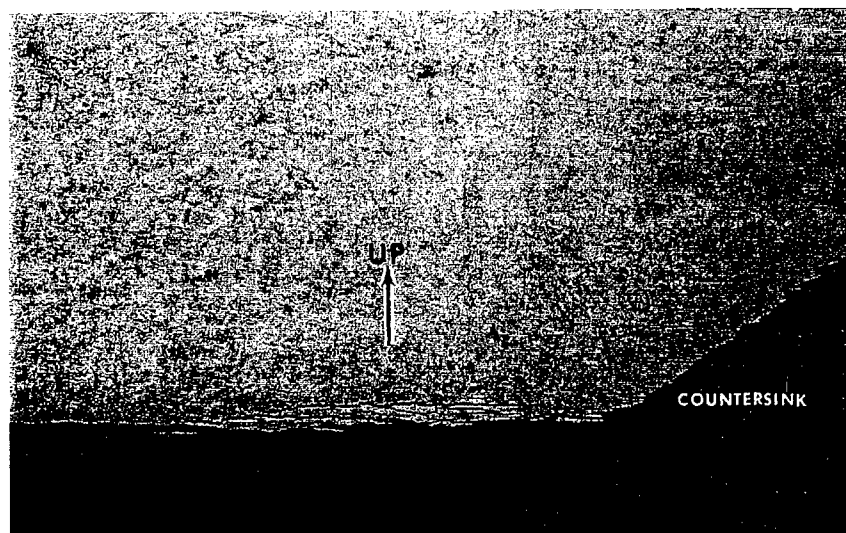
Figure 10a: "Typical" Wing Skin Countersink Degree and Extent of Corrosion

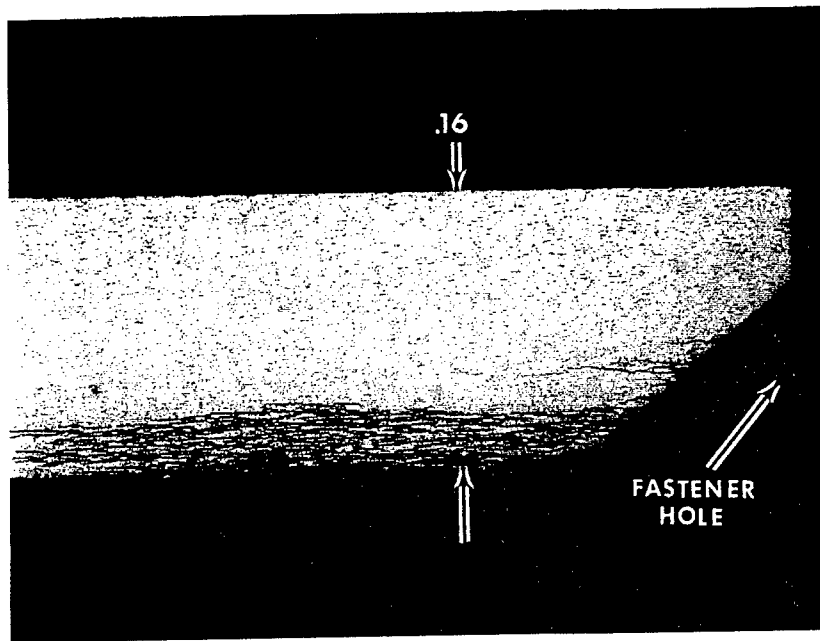
Figure 10b: Severe Wing Skin Countersink Degree and Extent of Corrosion

Scattered areas of severe corrosion damage were identified on all examined sections except Section 4/3 from CZ-180 which only had moderate corrosion damage. The most extensive severe corrosion occurred on Sections 1, 2, and 5 of CZ-184. The most numerous areas of corrosion damage on the skin exterior occurred around the countersink edge of fastener holes which contained steel fasteners. All of these fastener holes had some corrosion and a large percentage of them had "typical" amounts comparable to that shown in Figure 10a. Figure 10a shows a countersink cross section of a fastener hole which held a steel fastener. The photograph shows pitting in the countersink and initial stages of exfoliation. The exfoliation is 0.007 inch deep and extends 0.12 inch from the edge of the countersink. The most severe corrosion of this type is shown in Figure 10b. Very few other holes, if any, had comparable corrosion in the countersink area.

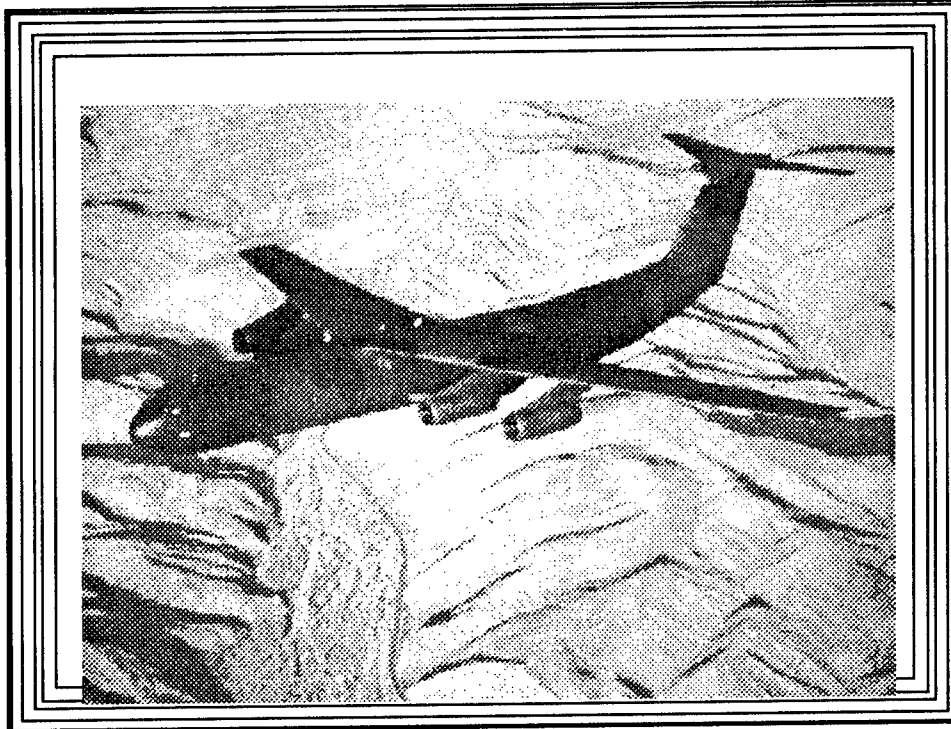
The C-141A was produced and delivered to the Air Force in the 1960's. The aircraft is mostly constructed of 7075 T6 aluminum alloys and was designed for 30000 flight hours of service. Stretched during the 1970s and with the addition of aerial refueling capability , this C-141B configuration became the work horse of MAC. Presently, there are 218 C-141s flying, some of which will fly into the 21st century. The Force is currently averaging 37500 damage hours and the present goal is 45000 damage hours on the lower surface spanwise splices.

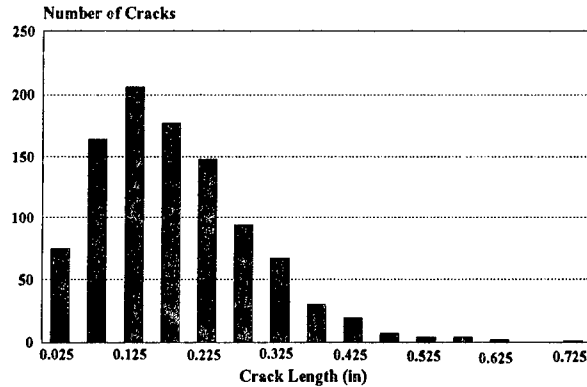
WS405 CRACK SIZE DISTRIBUTION

Crack size distributions can be derived from field inspection data, teardown results, or an assumed initial flaw distribution. Field inspection data should be detailed, providing information on the number of sites inspected, the size and direction of flaws, and the flight hours or cycles at the time of the inspection. In general, a better fit to a continuous distribution (Weibull, log-normal, etc.) will be obtained if the flaws are grouped by location and direction. All flaws should also be adjusted to a particular baseline flight hour value using the mean crack growth curve. Now having said that, it is a well known fact that field data will not be this complete. The data will be grouped around certain lengths, but crack depths will not be available and so on. An example of this can be seen in the crack data obtained from an inspection of the beam cap later.

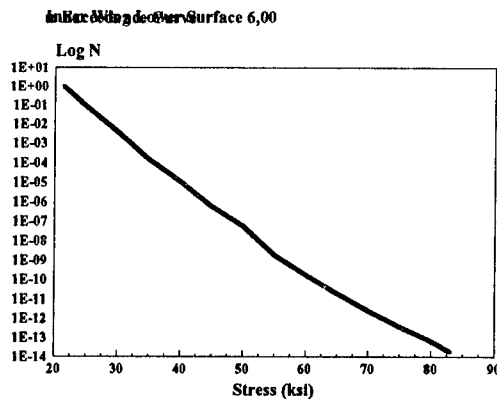
Risk Loads vs Probability

C-141 risk analysis has typically employed two approaches to obtain the spectra for this type of analysis. One of these methods is to select the worst mission of the Baseline Missions set and calculate the risk for it. The second method is to pick a reasonable time of usage such as between PDM. cycles (6,000 hours). Longer intervals are more conservative, but may be unreasonable for the short-term. Assuming single flight stresses for "return-to-base" or fail-safe capability could be unconservative, there can often be wide variations in stresses on a single flight. However, the idea is to provide the risk for an average aircraft during the time period of the analysis. Otherwise, the answer will come back the same as the standard deterministic methods of analysis. During our initial program evaluation, we looked at an in-house program that gave the same answers as the slow crack growth method.

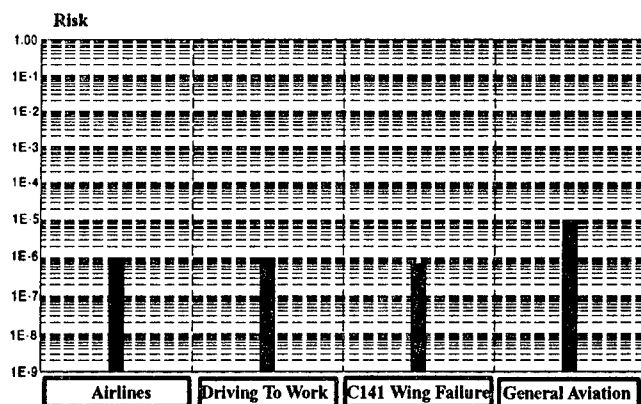
RISK COMPARISONS

This table presents the different levels of risk in graphical form. Generally, the risk of a major accident while driving to and from work is 1E-6 (1 in a million). The probability of a fatal accident in a light plane is 1E-5 (1 in one hundred thousand). For safe operations of military aircraft the risk should not be greater than 1E-7 (1 in ten million). When the risk starts to exceed 1E-6 (1 in a million), consideration should be given to repair or replacement, and the risk can only exceed 1E-5 (1 in a hundred thousand) for a very short period of time (generally the time to bring corrective action to closure).
